INFLUENCE OF MICROSTRUCTURE AND SECOND PHASES ON FRACTURE TOUGHNESS

BATTELLE
COLUMBUS LABORATORIES
COLUMBUS, OHIO 43201

JUNE 1975

FINAL REPORT 1 JUNE 1971 — 31 MAY 1974

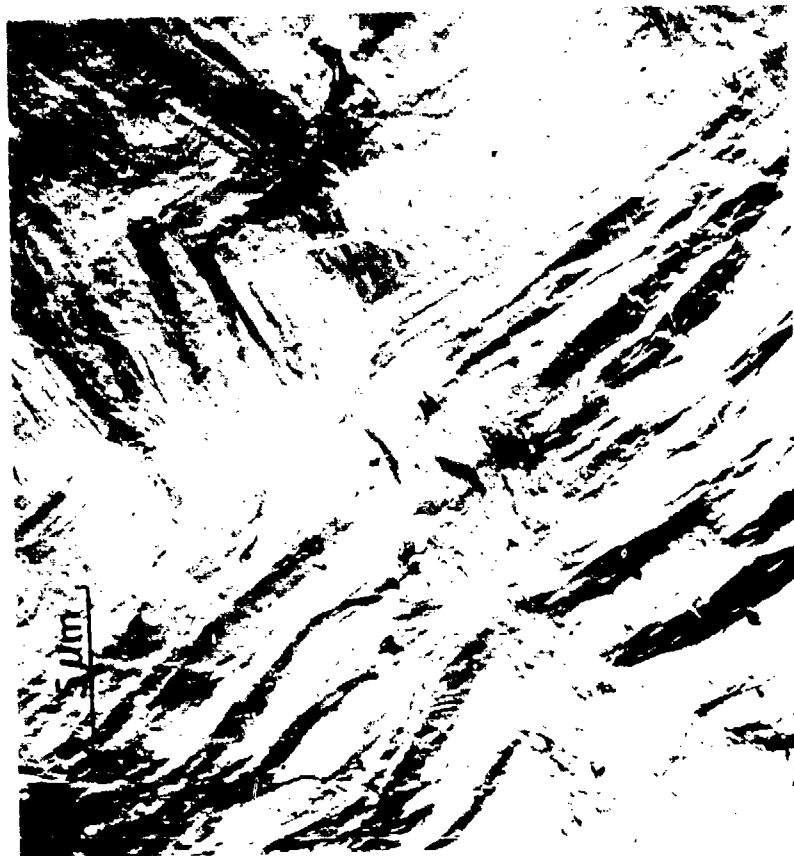
FIGURE 22. SLIP MARKINGS ON THE SURFACE OF 538°C TEMPERED AISI 4340 STEEL BEND SPECIMENS: (a) SEM micrograph, and (b) transmission micrograph of a cellulose acetate replica. The hole in (a) was probably associated with an inclusion particle

Figures 22 and 23 show the appearance of individual slip bands at higher magnifications. These bands are typically 10 μm to 20 μm long and involve slip offsets as large as 2-3 microns. Figures 24 and 25 show that cracks tend to form at the base of large 2-3 μ slip offsets. Figure 26 shows the distribution of the size of slip offsets measured on the surface of samples tempered at different temperatures. In all cases, the bulk of the slip offsets is smaller than 1 μm . However, there are indications that larger offsets are obtained for a given strain as the tempering temperature is reduced. There is also an indication (see Figure 27) that the slip band offsets at the various tempered conditions may be comparable when the comparison is made at $\bar{\epsilon}_1 = \bar{\epsilon}_{PS}$, the strain corresponding to the onset of fracture.

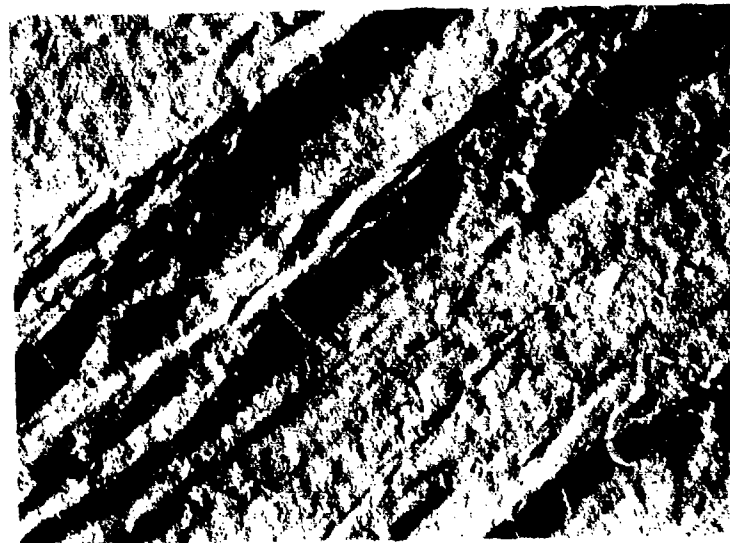
FIGURE 23. SLIP OFFSETS ON THE SURFACE OF 538°C TEMPERED AISI4340 STEEL BEND SPECIMENS OBSERVED ON TRANSMISSION MICROGRAPHS OF CELLULOSE ACETATE REPLICAS

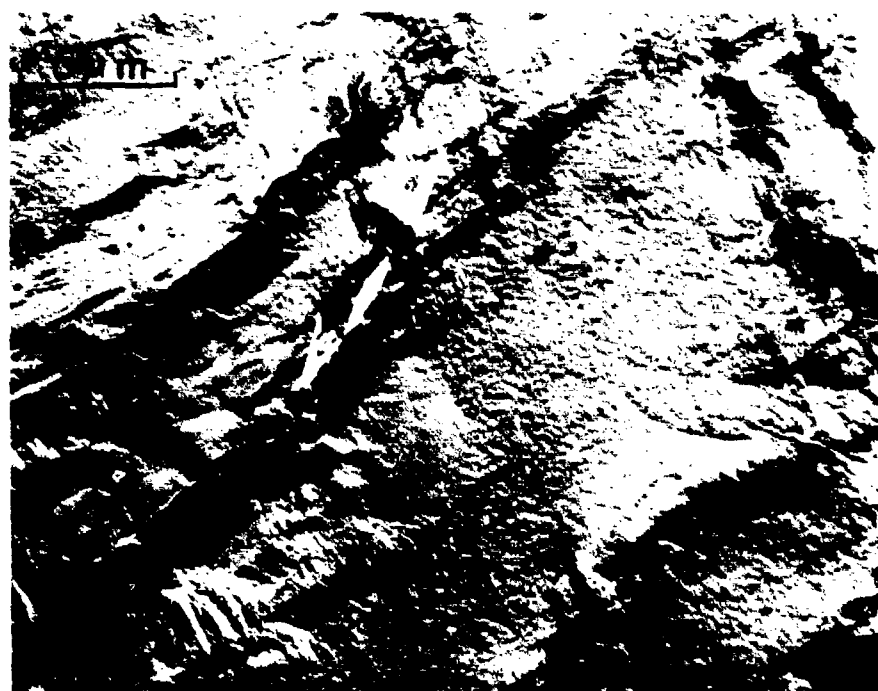
FIGURE 25. CRACKS AT THE BASE OF LARGE SLIP OFFSETS ON THE SURFACE 538°C TEMPERED AISI4340 STEEL BEND SPECIMENS. The cellulose acetate replicating medium which seeped into the crack cavity looks like a tongue on the stripped replica and cast a long shadow

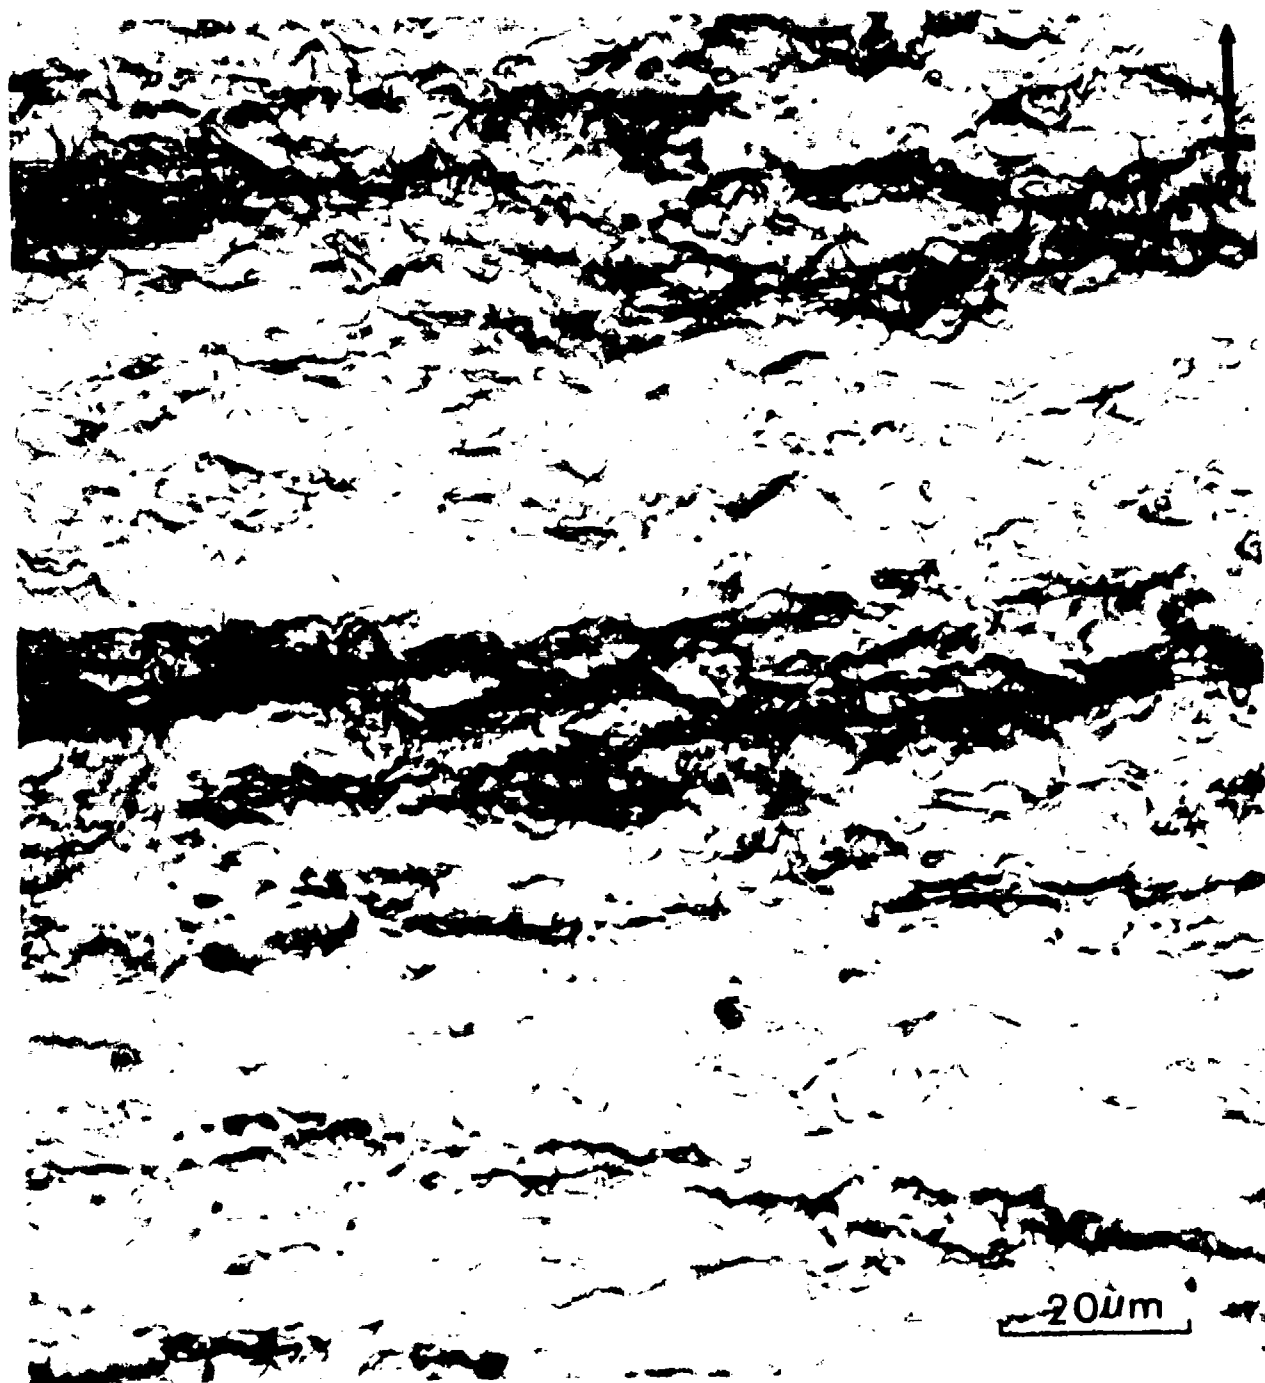
FIGURE 30. APPEARANCE OF SUPERBANDS ON THE SURFACE OF 250-GRADE MARAGING STEEL "PLANE-STRAIN" (DOUBLE) BEND SPECIMEN: (a) superband and (b) example of a cracked band. Material in the peak aged condition; $\bar{\epsilon}_{PS} \geq 0.40$

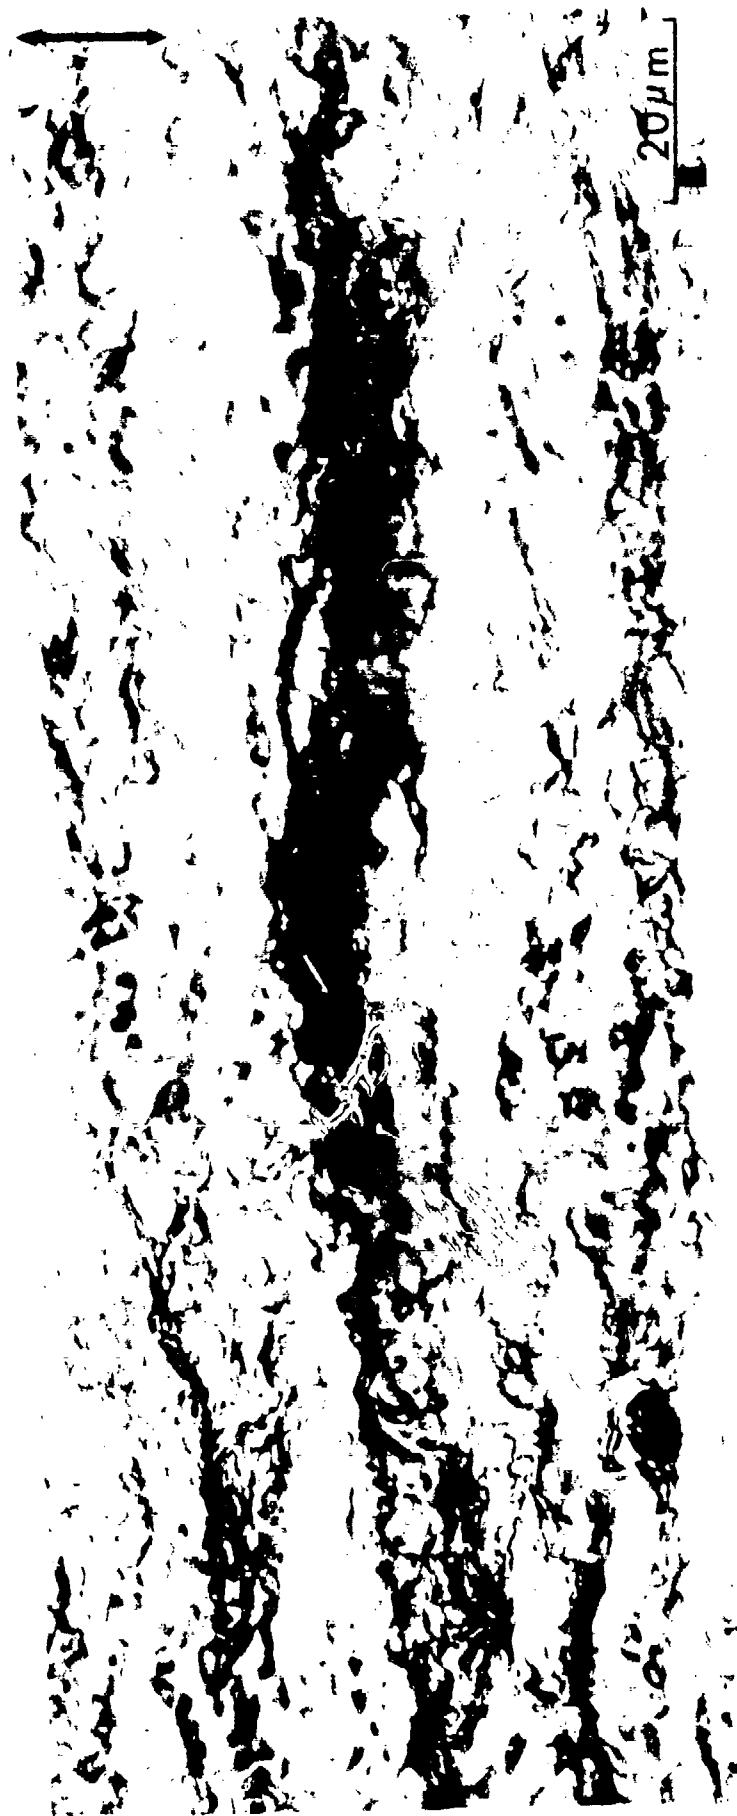
FIGURE 31. EXAMPLE OF A CRACKED SUPERBAND ON THE SURFACE OF 250-GRADE MARAGING STEEL "PLANE STRAIN" (DOUBLE-BEND SPECIMEN. Material in peak-aged condition; $\bar{\epsilon}_{ps} \geq 0.40$)

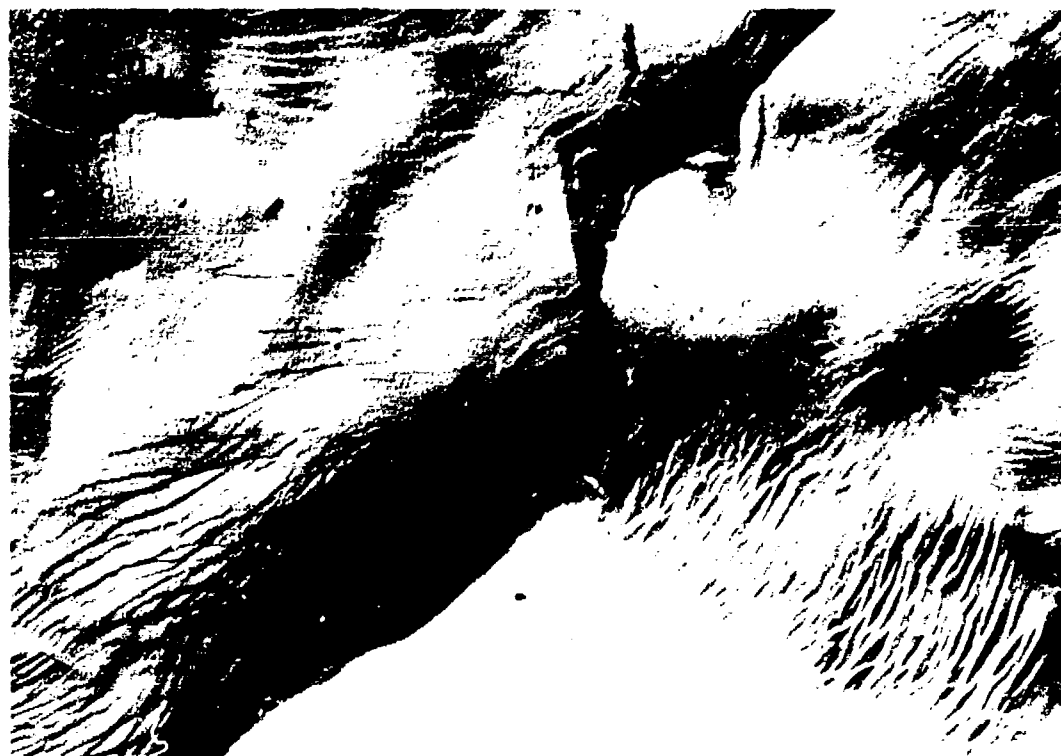
FIGURE 33. SLIP MARKINGS ON THE SURFACE OF 300-GRADE MARAGING STEEL IN THE PEAK-AGED CONDITIONS SHOWING SLIP BANDS AND GRAIN BOUNDARY OFFSETS: (a) cracked superband and (b) grain boundary offsets in the vicinity of the band

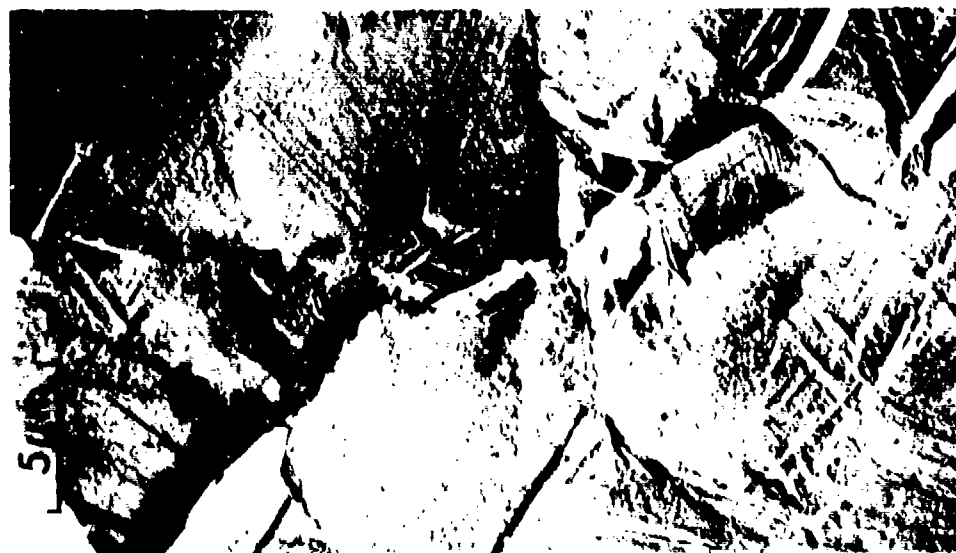
FIGURE 39. TRANSMISSION MICROGRAPHS OF CELLULOSE ACETATE REPLICAS OF THE SURFACE OF AGED Ti-6Al-4V BEND SPECIMENS. The photographs show slip offsets and fissures developing at the grain boundaries

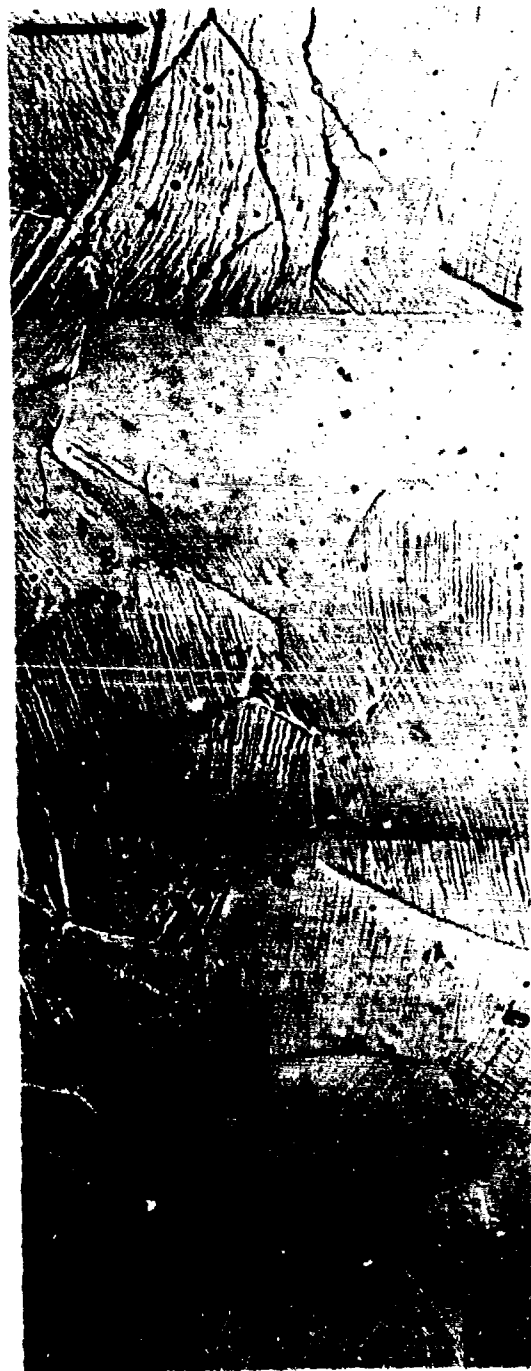
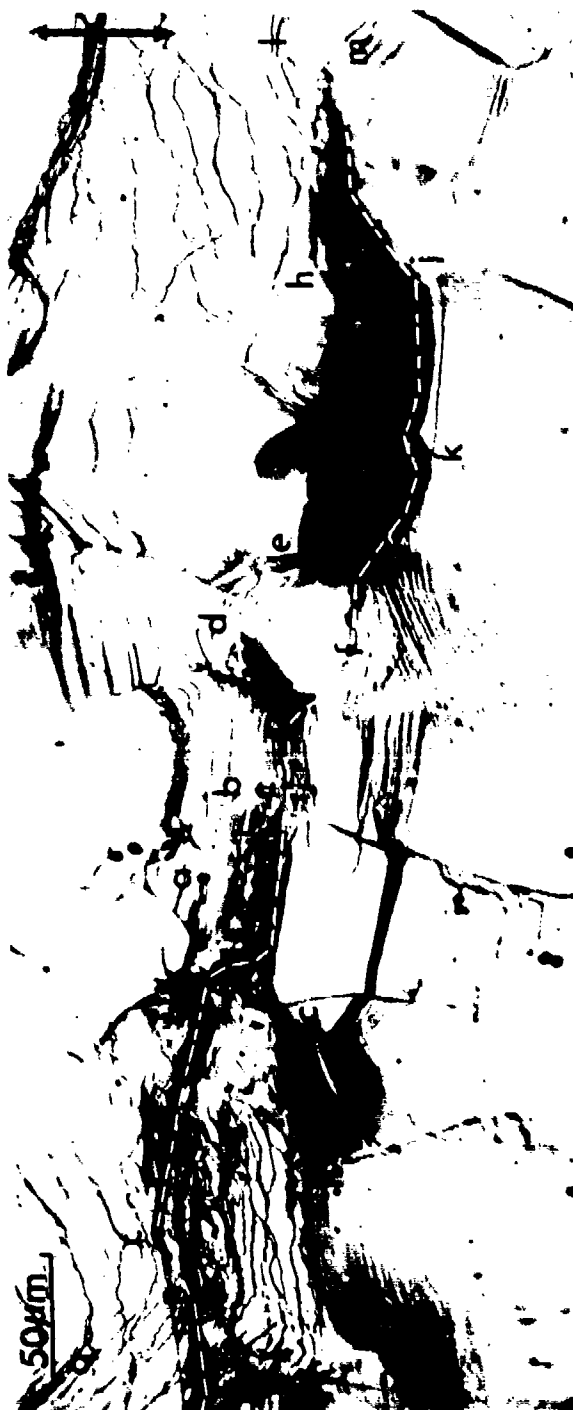
FIGURE 44. CLOSE-UP OF THE DEVELOPMENT OF A SUPER BAND ON THE SURFACE OF AN ALUMINUM ALLOY X BEND SPECIMEN IN THE PEAK AGED CONDITION: (a) $\bar{\epsilon}_1 = 0.09\%$, (b) $\bar{\epsilon}_1 = 0.12\%$, (c) $\bar{\epsilon}_1 = 0.18\%$, (d) $\bar{\epsilon}_1 = 0.18\%$, (e) $\bar{\epsilon}_1 = 0.26\%$, and (f) $\bar{\epsilon}_1 = 0.35\%$. The arrow in Figure (d) points to a feature that looked like an inclusion particle just below the surface. The letters in (e) and (f), which identify common features on the two photographs, provide a basis for locating the path of the fracture (see dashed line in (e)). The arrow in Figure (a) shows the principal $\bar{\epsilon}_1$ - strain direction

the grains. Higher magnification electron micrographs showed that the deformation of the aged condition had two distinct components, (a) coarse slip and (b) fine slip, as shown in Figure 49. Cracks invariably initiated at the base of the coarse slip bands with $\sim 2\text{ }\mu\text{m}$ - $4\text{ }\mu\text{m}$ offsets (see Figures 50 and 51). Figure 44 provides little evidence that crack initiation in this alloy is assisted by inclusions visible on the surface. Figure 44(a) shows a feature near a triple point that may be subsurface inclusion.

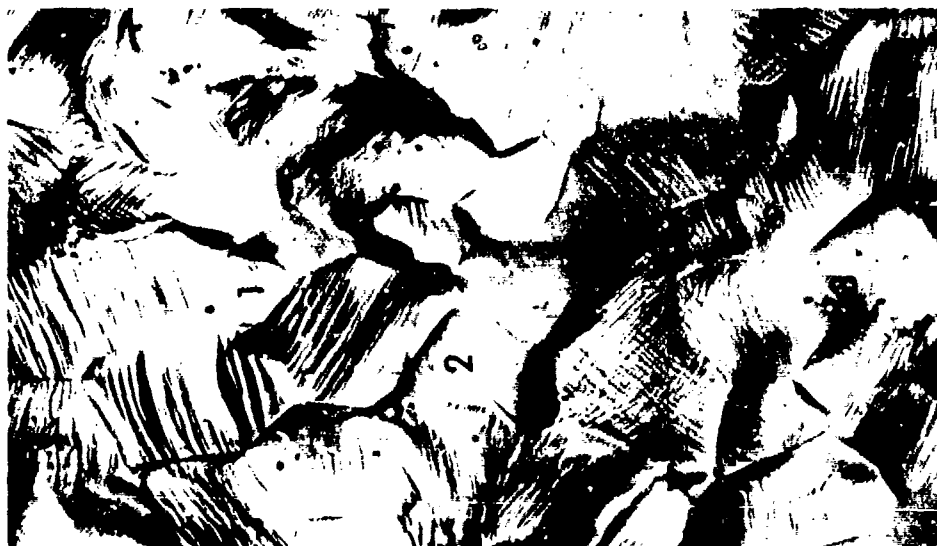
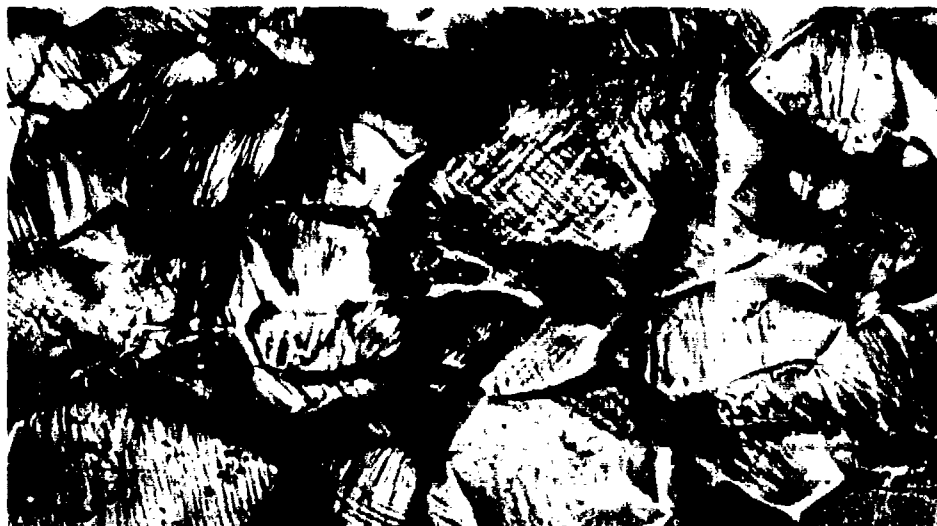
FIGURE 45. DEFORMATION MARKINGS ON THE SURFACE OF ALUMINUM ALLOY X "PLANE STRAIN" BEND SPECIMENS IN THE AS-SOLUTION TREATED. The photographs are of cellulose acetate replicas of the same region after different amounts of strain: (a) $\bar{\epsilon}_1 = 0$, (b) $\bar{\epsilon}_1 = 0.22$, and (c) $\bar{\epsilon}_1 = 0.39$. The numbers on the photographs identify individual grains that appear on all three replicas. The arrow in Figure (a) shows the principal $\bar{\epsilon}_1$ -strain direction

- 4) The large reduction in plane strain ductility that accompanies the overaging of Alloy X (see Figure 40) is associated with a change in mechanism of cracking. As shown in Figures 45 and 46, prominent superbands are visible in the overaged material, but the cracks are mainly intergranular.

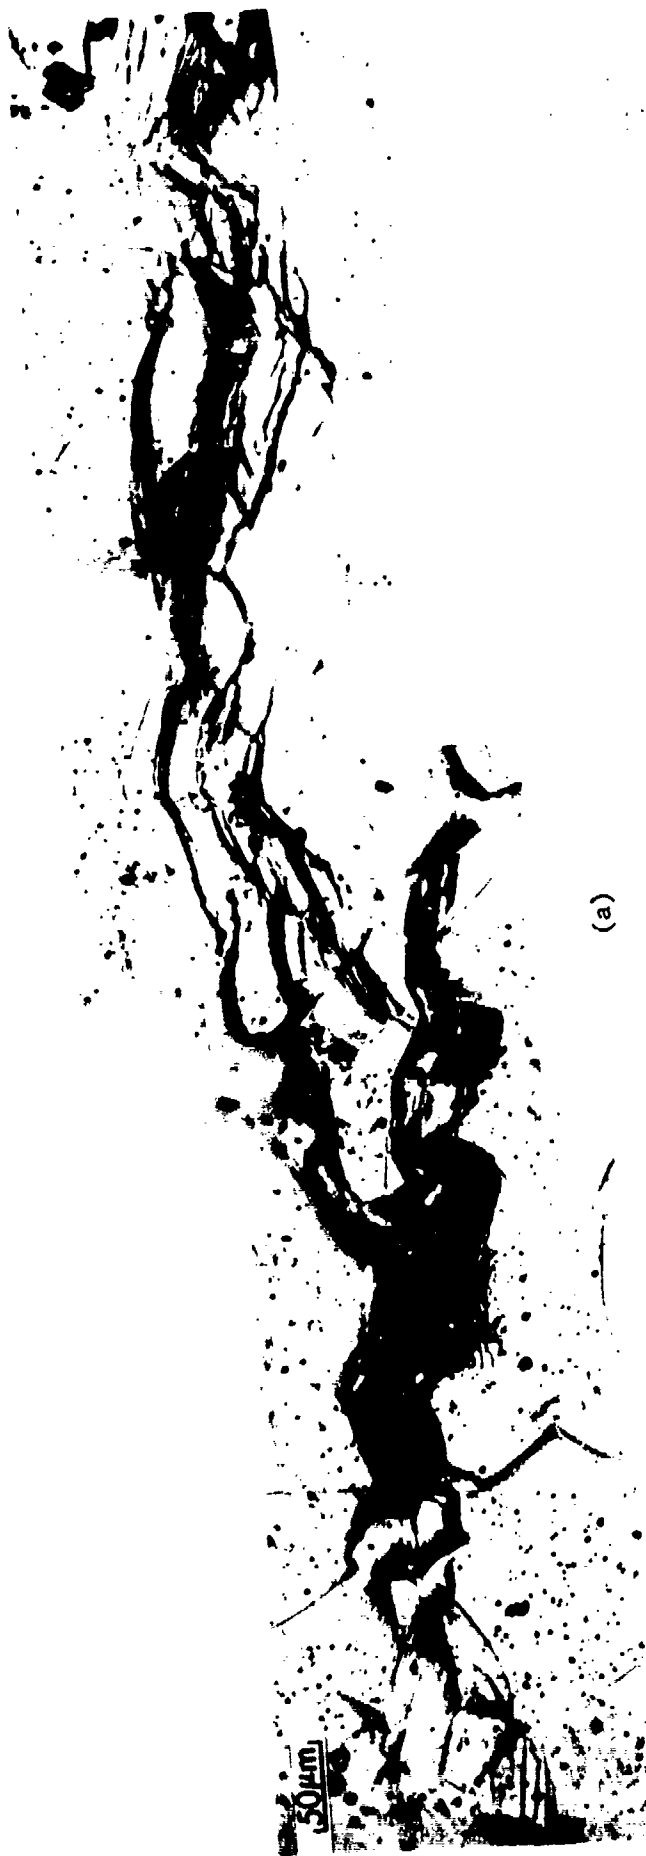
FIGURE 47. OPTICAL MICROGRAPHS OF THE SURFACE OF A PLANE STRAIN BEND SPECIMEN OF A 7000-SERIES ALUMINUM ALLOY IN THE OVERAGED CONDITION, $\bar{\epsilon}_{PS} = 0.22$: (a) portion of a superband showing grain boundary ruptures (arrows) and (b) other examples of grain boundary ruptures. WQ and aged 4 hrs at 120°C and 10 hrs at 163°C

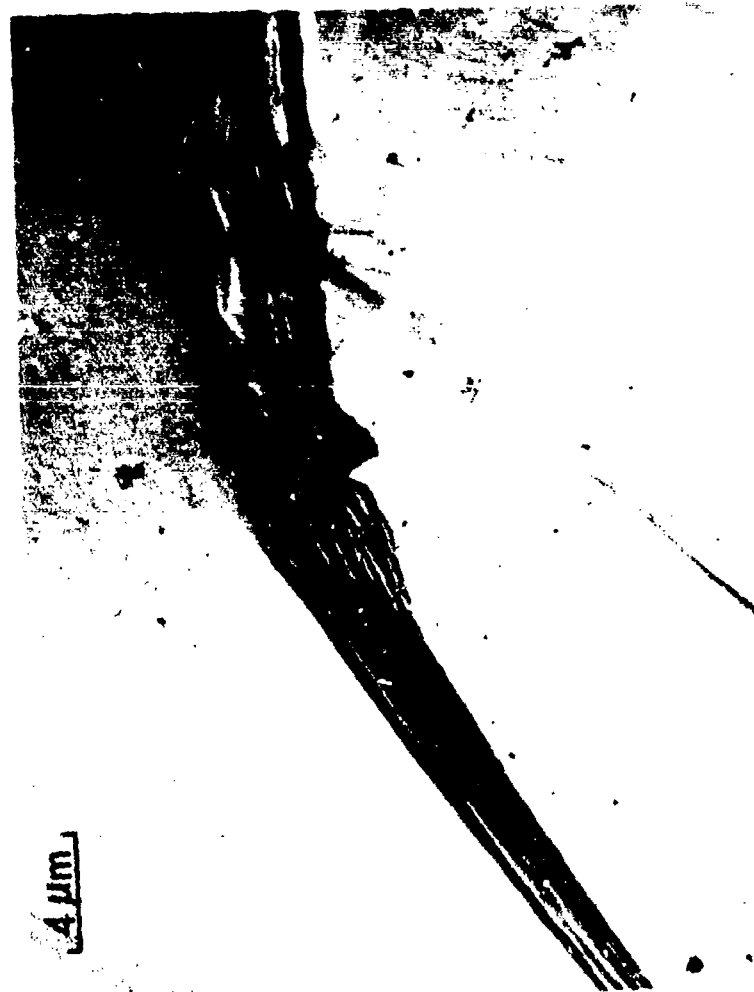
FIGURE 51. EXAMPLES OF COARSE SLIP BANDS: (a) Alloy X in the peak aged condition, and (b) 7075-T6 Alloy. The small tongue at the base of the slip band in (a) is a sign a crack nucleus has formed.

Micrographs of the surface "plane strain" bend specimens of the 7075-sheet alloy (see Figure 52(a), (d), and (e)) display prominent superbands. Compared with Alloy X (Figure 42), the commercial alloy displays a finer and indistinct grain structure and many more inclusion particles. Higher magnification pictures (Figures 51(a), 52(b), (c), (f), and (g)) reveal that the cracks are initiated at the base of prominent bands whose traces on the surface are normal to the maximum principal stress direction (the y-direction in Figure 4). Because the cracks are essentially straight, transgranular, and normal to the tensile axis, the cracked slip bands bear a superficial resemblance to cleavage microcracks in mild steel.⁽³²⁾ In contrast to Alloy X, the overaged 7075-sheet alloy specimens were not embrittled and did not display obvious grain boundary cracks (see Figures 52(f) and (g)). However, the slip bands were frequently associated with ruptured inclusions on the surface (see Figures 51(b), 52(c), and 52(f)).

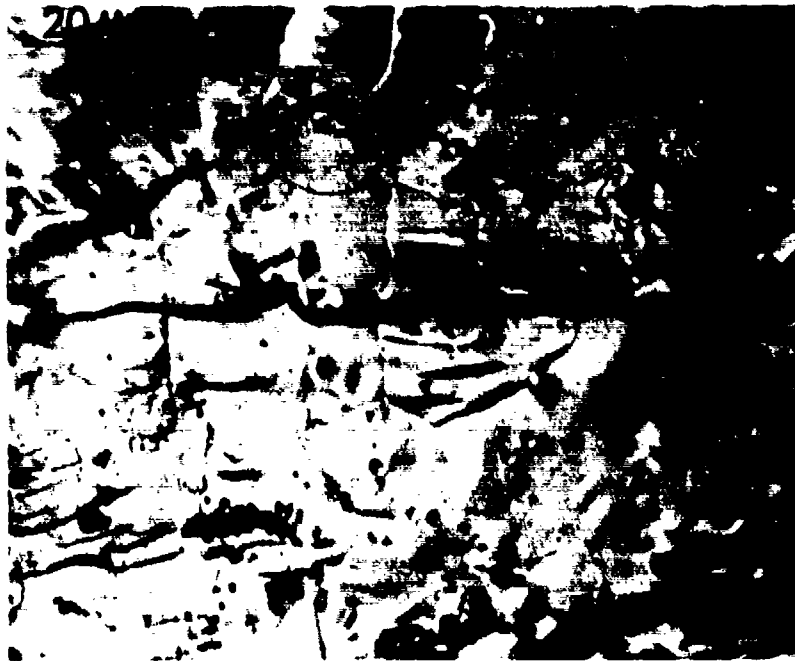
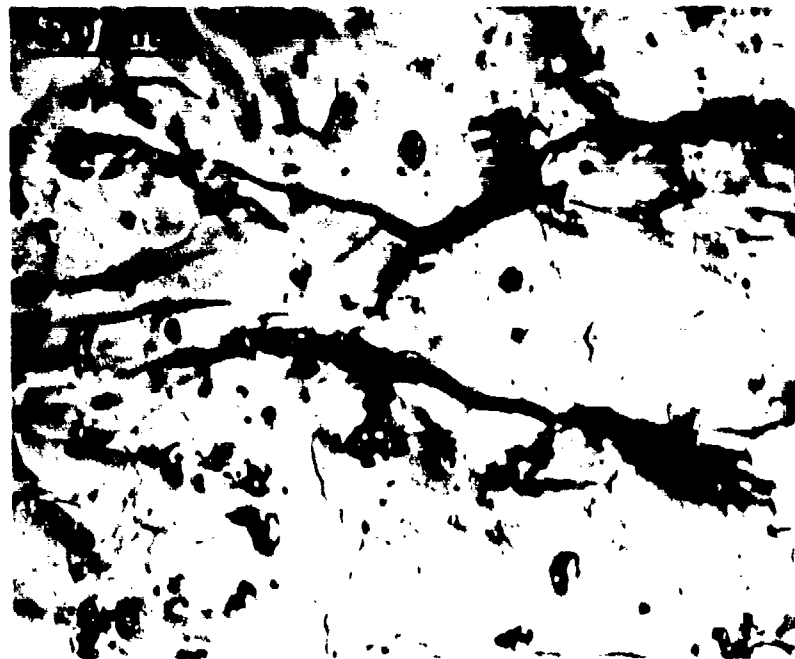
FIGURE 52. MICROGRAPHS OF THE SURFACE OF 7075-ALUMINUM ALLOY SHEET "PLANE-STRAIN" DOUBLE-BEND SPECIMENS: (a) as received condition $\bar{\epsilon}_{ps} = 0.16$, (b) and (c) higher magnification of slip bands on (a); (d) same material solution treated 20 min. at 485°C, WQ and aged 24 hrs at 120°C, $\bar{\epsilon}_{ps} = 0.22$, (e) same as (d) except WQ and overaged 4 hrs at 120°C and 10 hrs at 163°C; $\bar{\epsilon}_{ps} = 0.19$, (f) and (g) show higher magnification of slip bands on (e). The arrows show the principal, $\bar{\epsilon}_1$ -strain direction.
